Subject:	Pico Avenue Beach Access Stairs Observation
AV Job #:	240978
Project:	Beach Access Stairs Pico Avenue San Simeon, CA
То:	Patrick Faverty San Simeon Community Services District
Date:	June 27, 2024

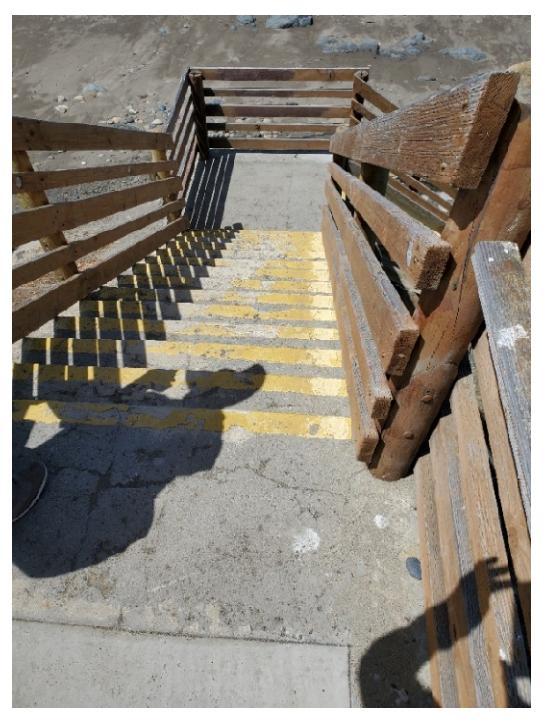
Figure 1

While on site, significant concrete cracking, concrete deterioration, guardrail damage, undermining of the stair supports and bluff erosion was observed (All Figures). The stairs were viewed from above (Figure 1 & Figure 6), as well as from the beach (Figure 2). It is our assumption that the deterioration of the stairs has likely been caused by exposure to the surrounding environment and natural elements, such as wind, wave impact, and salt water.

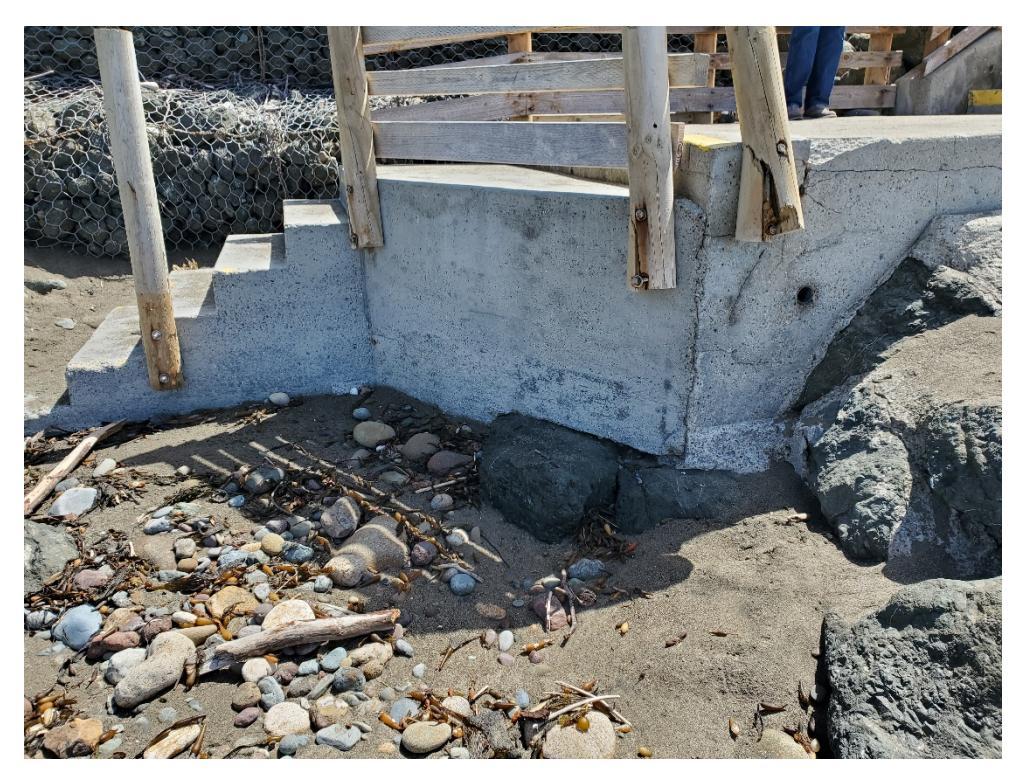
Figure 4

The condition of the wood guardrails varied with some sections being completely unusable. Multiple guardrail posts were cracked and failing at their connections to the concrete (Figure 4), compromising their ability to resist lateral forces and presenting a safety hazard to users. These deteriorated connections increase the risk of the guardrails detaching from the stairs under minimal force, posing a significant fall hazard.

In conclusion, it is our opinion that the stairs should be removed and/or replaced due to the potential risks associated, as explained in this memorandum.

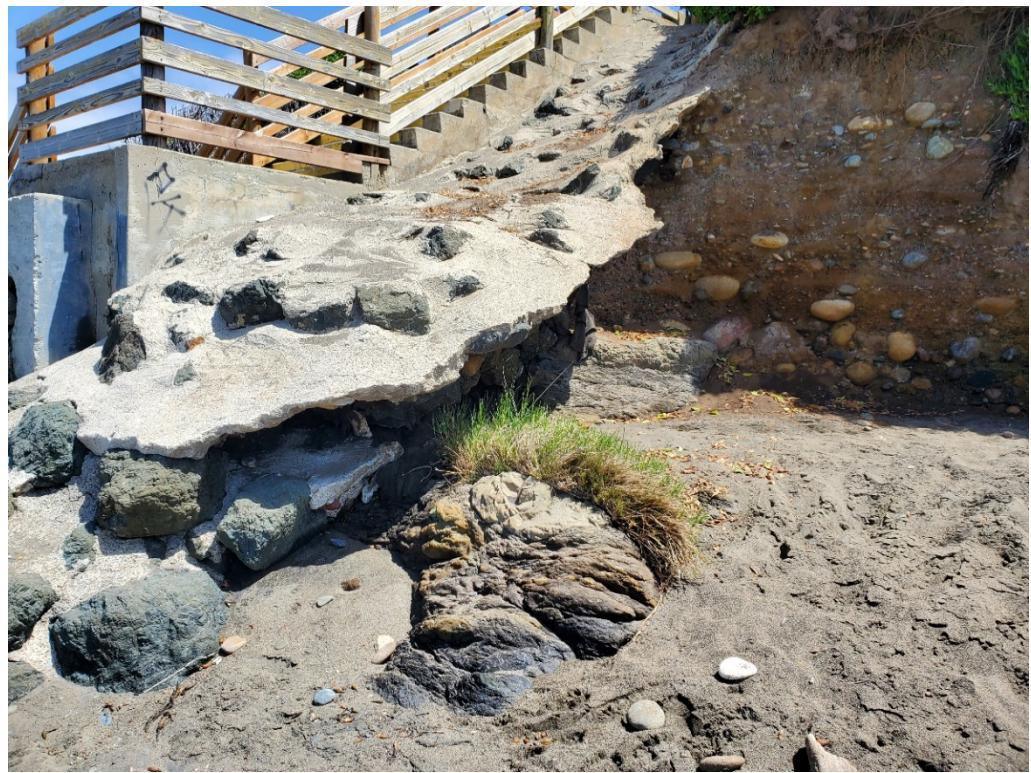
Figure 5

Rock slope protection (RSP) and a gabion rock wall appeared to be used for earth retention both underneath and immediately adjacent to the stairs. Portions of the RSP were mixed with a cementitious material to create a composite element. Severe erosion was observed below the composite RSP element on the south side of the stairs, causing the RSP element to cantilever, or remain suspended, over the adjacent ground (Figure 5). It is our opinion that the RSP was not intended for a cantilever condition and should be replaced or properly supported. The undermining of the RSP creates a significant hazard, potentially leading to sudden failure, which could pose a safety risk and further exacerbate the erosion issues.
