DRAFT REPORT ◦ NOVEMBER 2022

# Pico Creek Instream Flow Study

P R E P A R E D F O R

P R E P A R E D B Y

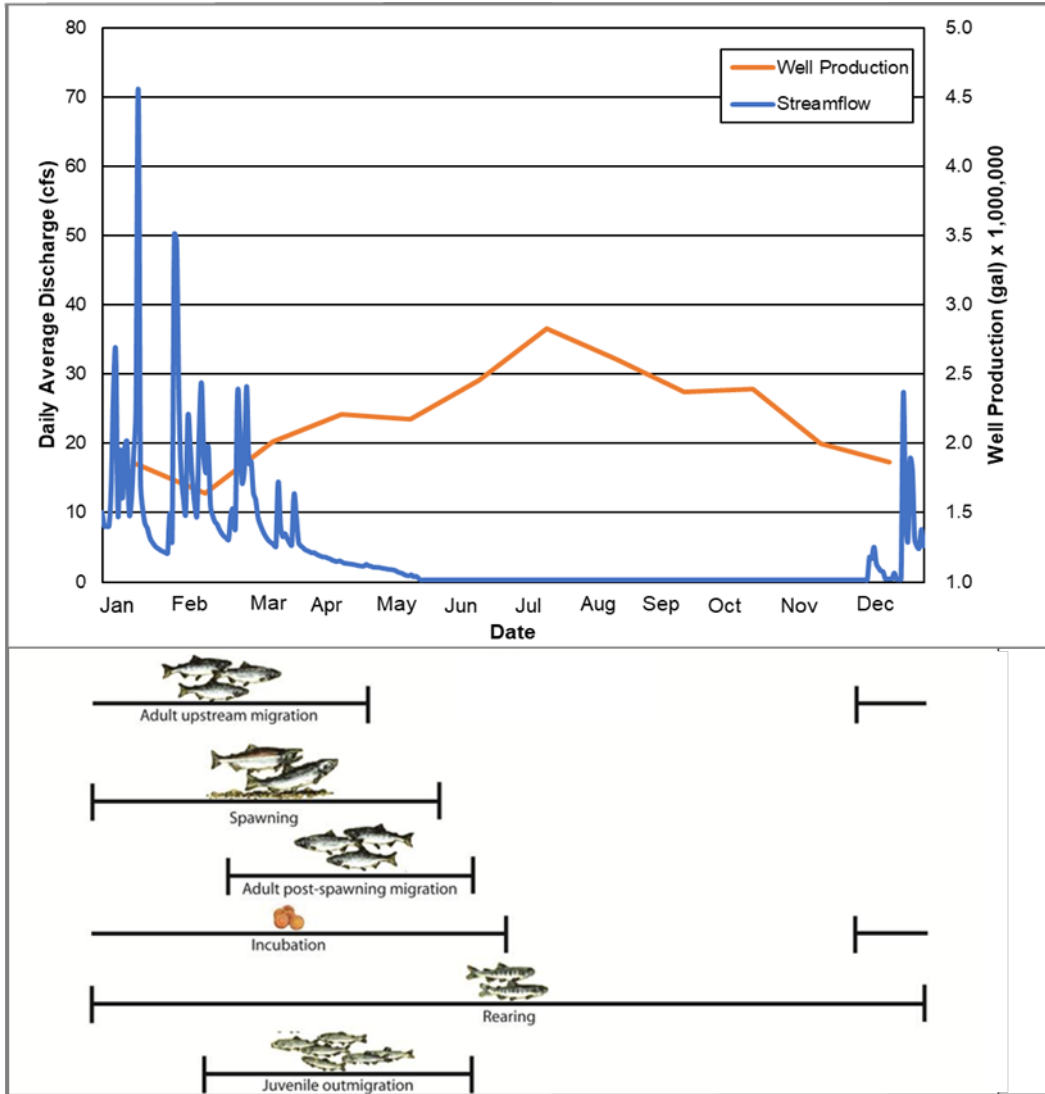
**Figure 2.** Hypothetical hydrograph showing seasonal flow variation within Pico Creek along with typical district pumping production volumes, and life history timing of steelhead (Shapovalov and Taft 1954).

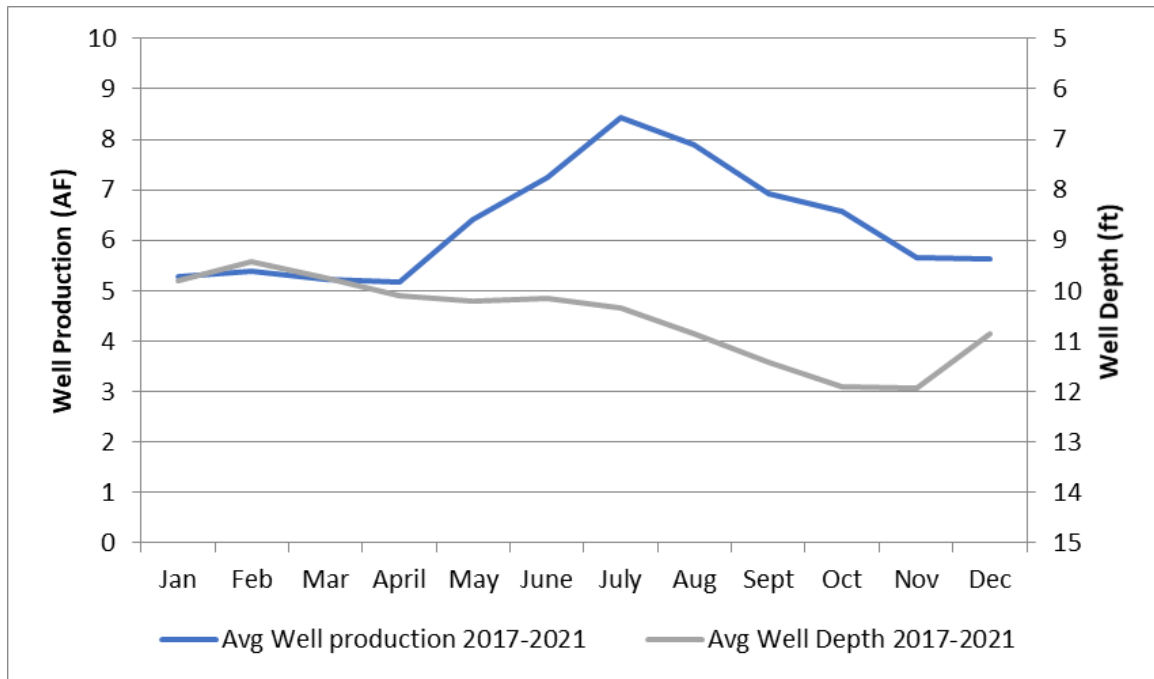
**Figure 3.** Monthly average groundwater well production and average well depth from District wells during 2017 through 2021.

Average monthly groundwater extraction ranges from 5.28 AF during the winter up to 8.44 AF a month during the summer (based on data collected between 2017–2021) (Figure 3), which is equivalent to daily average rates of 0.09 cfs and 0.14 cfs, respectively. Both wells are equipped with pumps that produce about 325 gallons per minute (0.72 cfs). However, water rights for the District limit groundwater extraction rates to a maximum daily average rate of 0.27 cfs.

The District provides water services to the unincorporated town of San Simeon through the operation of two groundwater wells located along lower Pico Creek, with a third well located on the Hearst Pico Creek Ranch that provides additional capacity during emergency drought conditions (Figure 1) (Cleath-Harris Geologists 2014). The Hearst Corporation also operates two wells along lower Pico Creek as part of the Hearst Pico Creek Stables, which provide irrigation and water to livestock at an average of 10-acre feet per year (AFY). The District has a water rights license issued by the California State Water Resources Control Board to extract up to 140-AFY from the Pico Creek Valley groundwater basin; however, average annual production averages between 70- and 80-AFY. Groundwater extraction typically increases during the spring and peaks during the summer due to the influx of tourists to the community of San Simeon during this time (Figure 3).

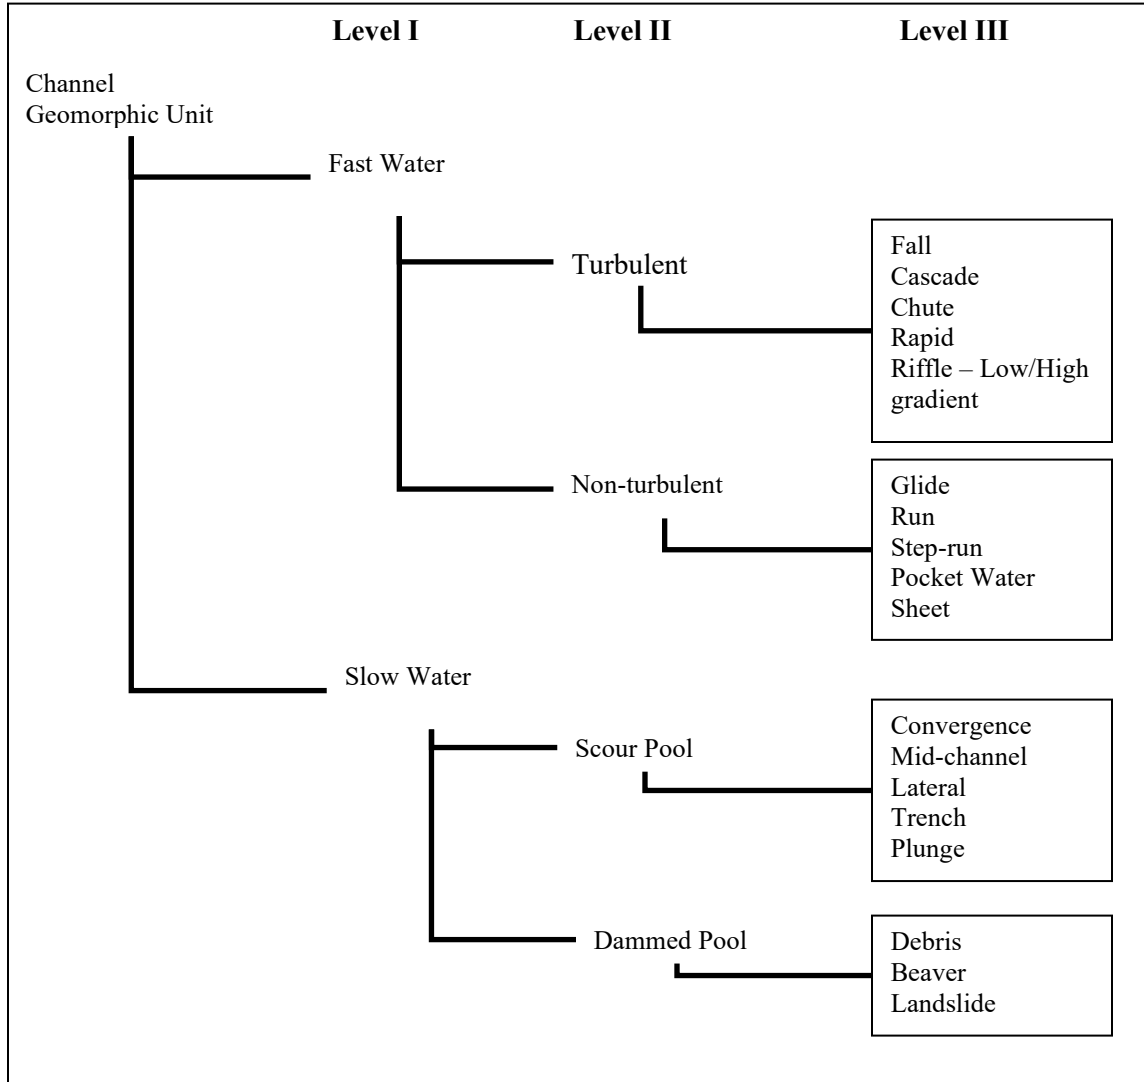
Surveys to characterize physical habitat conditions within the Study Reach were conducted at the beginning of the study. Habitat mapping was conducted when flows were near winter baseflow conditions to facilitate the evaluation of habitat composition while distinct habitat unit breaks were expected to be most apparent. Habitat mapping was conducted following methods developed by Hawkins et al. (1993), McCain et al. (1990), and Flosi et al. (2010), which uses a three-tiered habitat mapping classification system to assist in the identification of individual habitat units in the field. Level III categories are adopted from McCain et al. (1990). Figure 5 shows the relationship among the three levels.

**Figure 5.** Three-tiered habitat mapping classification system adapted from Hawkins et al. (1993) and McCain et al. (1990).

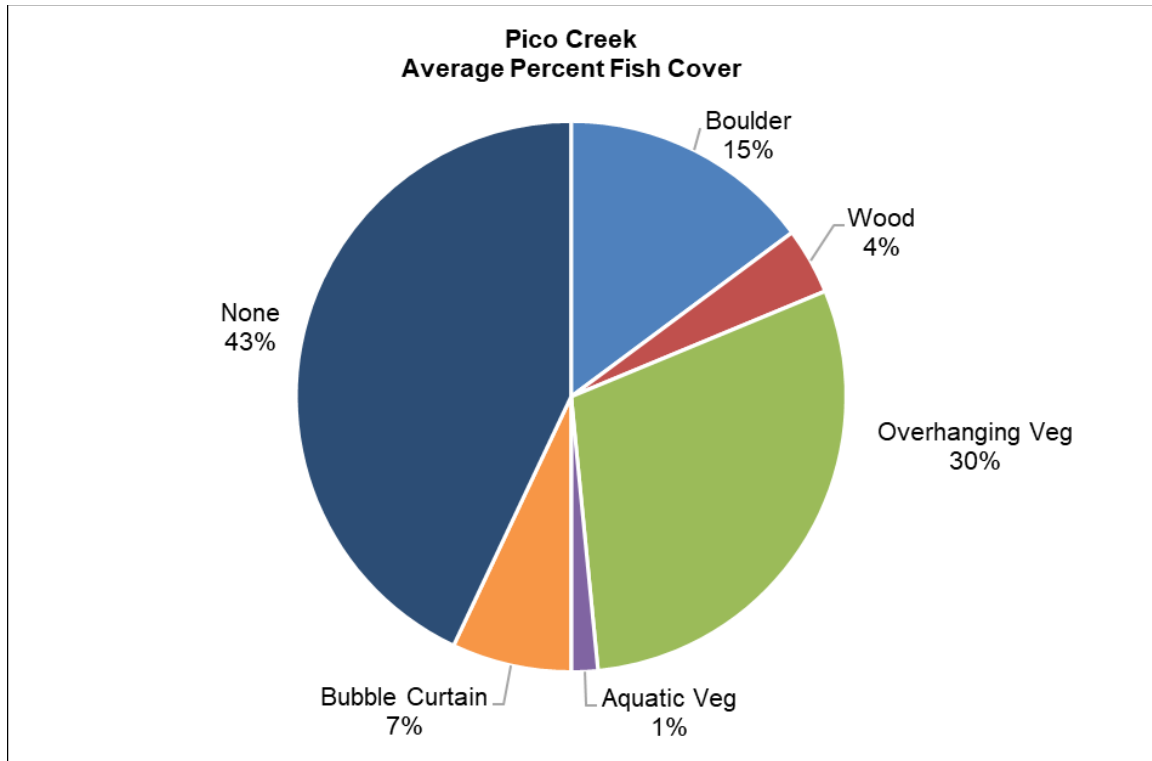
**Figure 9.** Average percent of fish cover within the Study Area.

Stream habitat typing was conducted throughout the Study Reach on January 14, 2022 beginning at the upstream end of the lagoon and extending approximately 0.83 miles upstream. The Study Reach is dominated by pool habitat (both mid-channel and lateral scour pools were observed), followed by riffle habitat and run habitat (Figure 7). Substrate within pool habitat was predominantly sand while the riffle and run habitats were dominated by cobble and gravel substrates, respectively (Figure 8). The majority of the channel (43%) contained no cover for fish. The dominant cover type was overhanging vegetation followed by boulder (Figure 9).

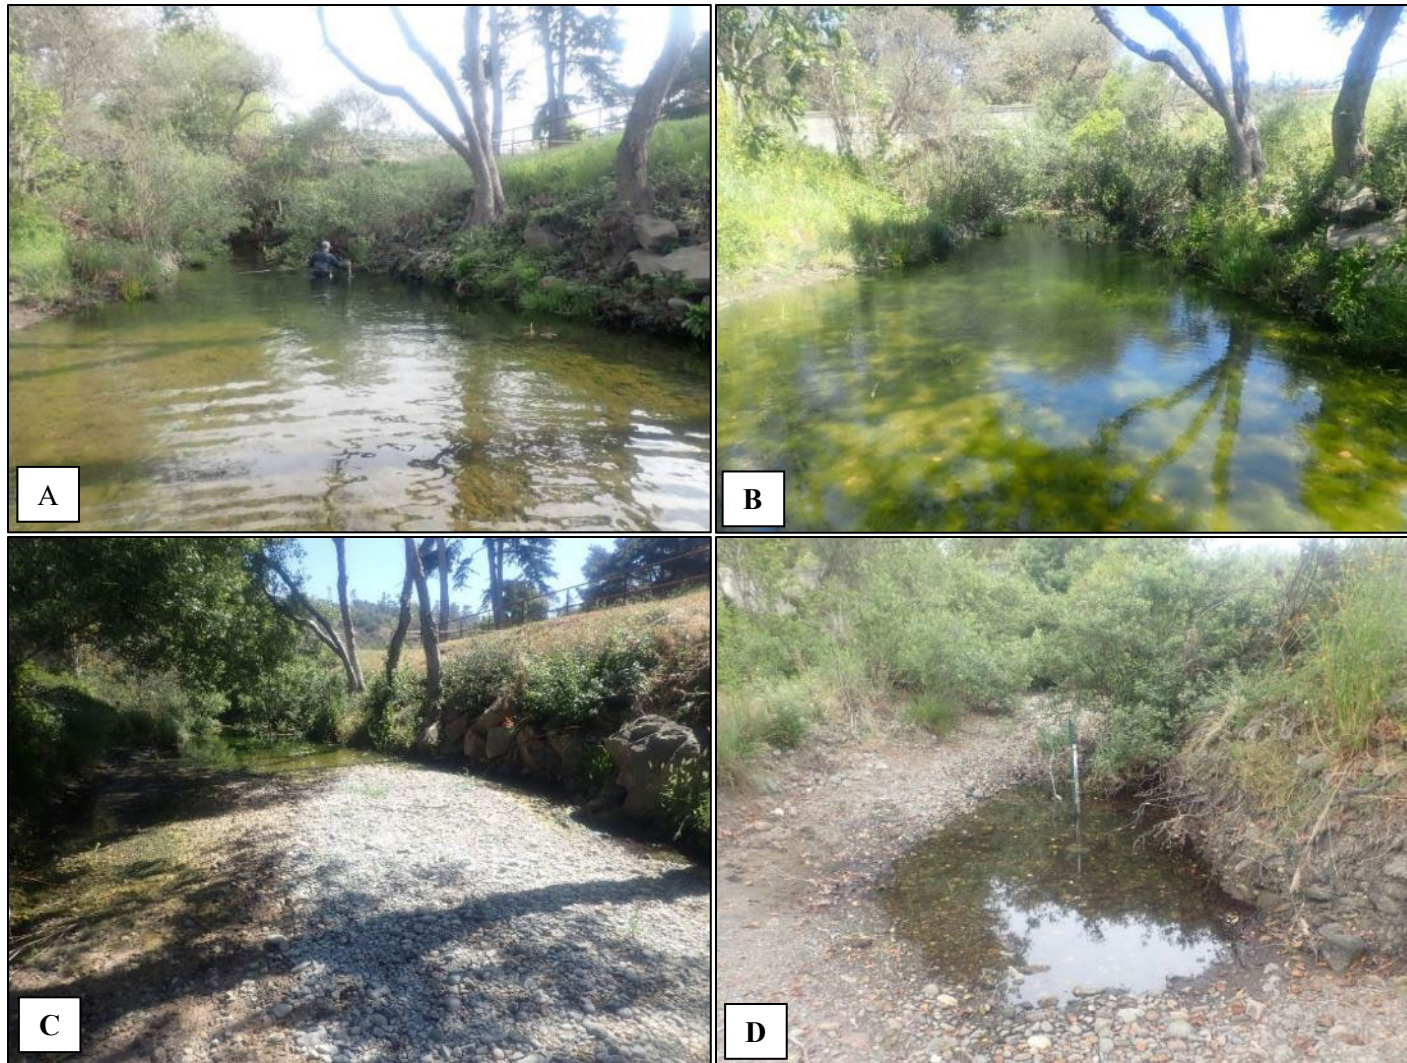
Figure 11. Looking upstream at pool where PT1 was installed on: (A) March 30 (0.86 cfs), (B) May 9 (0.05 cfs), (C) June 13 (0.0 cfs), and (D) July 12, 2022 (0.0 cfs).

Pressure transducers were installed in Pico Creek on March 15, 2022 when stream flow was 0.35 cfs. Water levels in pools were generally stable until surface flows became disconnected, at which point pool depths began to decrease quickly. Pool depths showed a quick response to rain events that occurred in late March and in late April. The April rain event occurred after stream flows had become disconnected in the upper section of the Study Reach, when water depths at the pools where PT2 and PT3 were located began to drop. Following the April rain event, water levels in these locations briefly rose by approximately 0.5 ft but then began dropping almost immediately (Figure 10). Photos of each pool where pressure transducers were installed are shown in Figures 11–13.

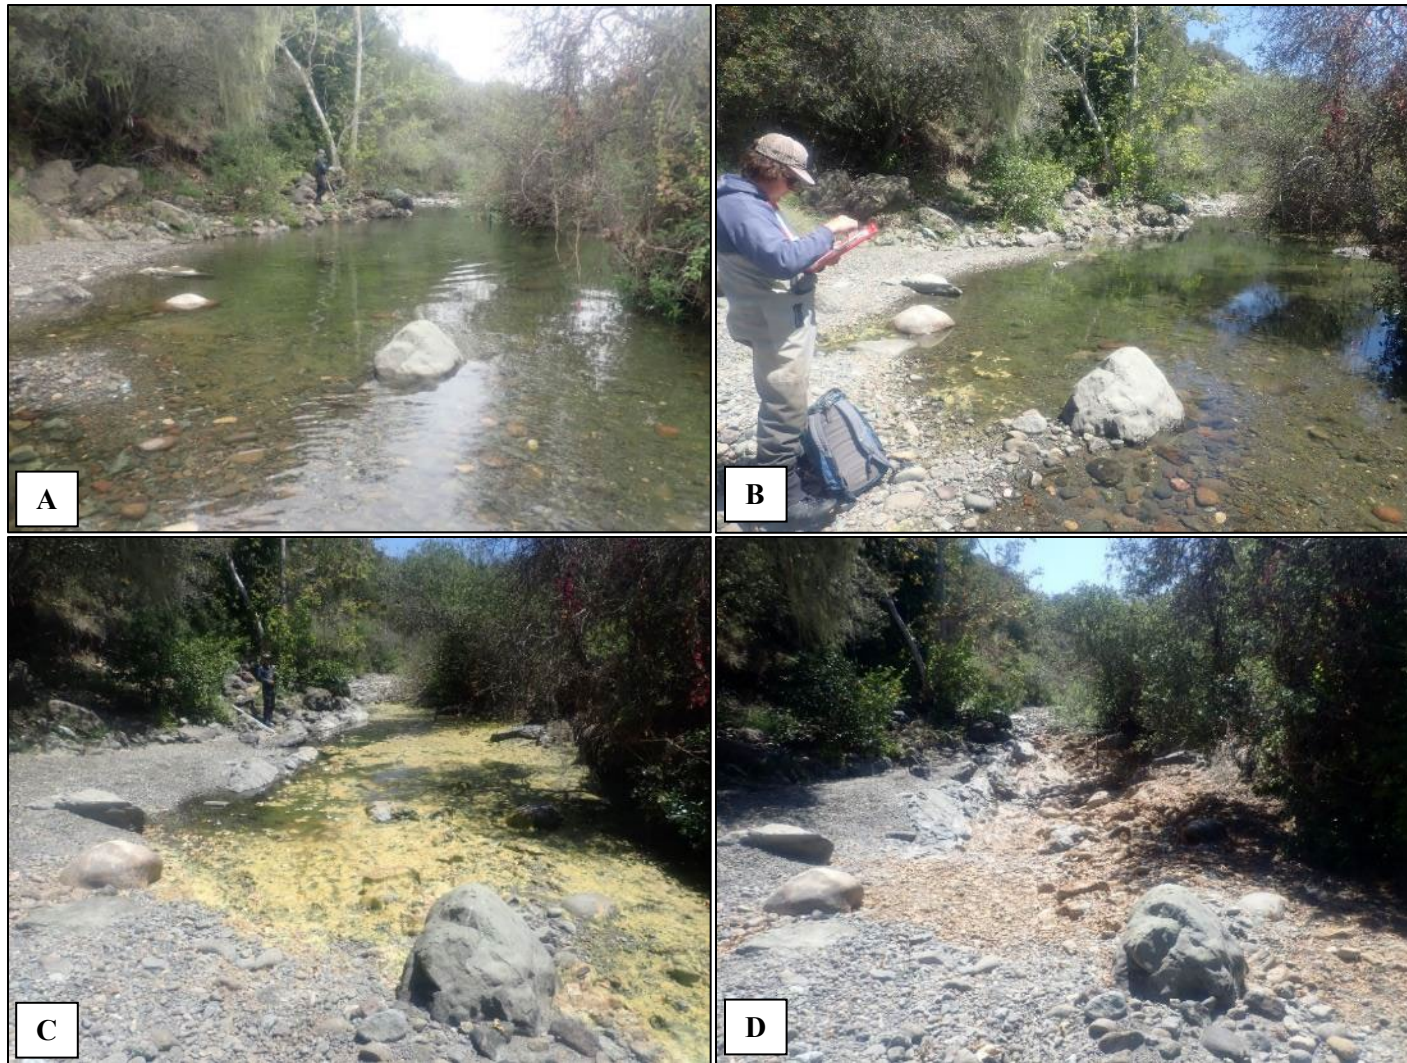
Figure 12. Looking upstream at pool where PT2 was installed on: (A) March 30 (0.86 cfs), (B) April 15 (0.14 cfs), (C) May 9 (0.05 cfs), and (D) June 13, 2022 (0.0 cfs).

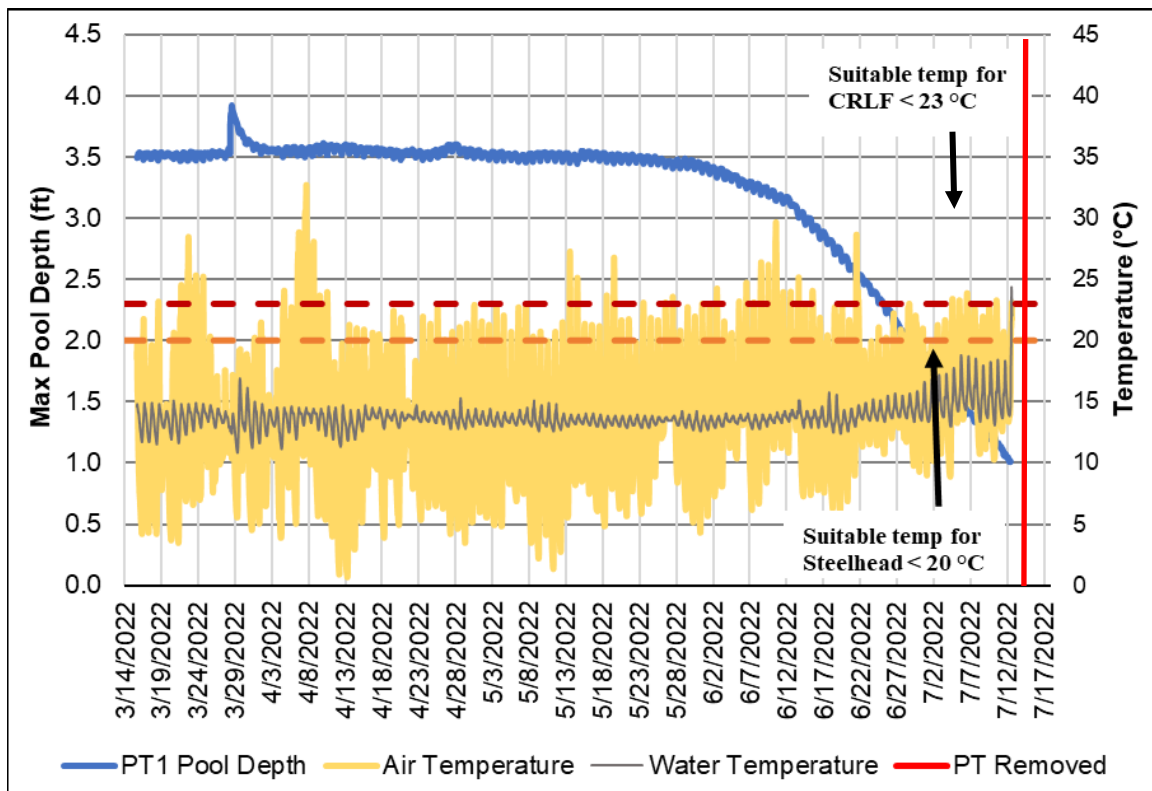
Figure 15. Pool depth and water temperature monitored at PT1.

Ambient temperature was recorded on PT1, PT2, and PT3 during the study. All three pools where pressures transducers were installed provided suitable water temperatures for steelhead and CRLF until the pools became dry. Stable and cool water temperatures were recorded on the PTs until pool depths began to decrease. As pool depths decreased, water temperatures became more responsive to the daily fluctuations in air temperature. The downstream end of the Study Reach remained wet later into summer than pools at the upstream end of the Study Reach. Water temperatures recorded at PT1, which remained under water throughout the study, never exceeded suitable levels for steelhead or CRLF (Figure 15) while water temperatures recorded at PT2 and PT3 remained suitable for steelhead and CRLF until they became dry in late May (Figure 16 and Figure 17).

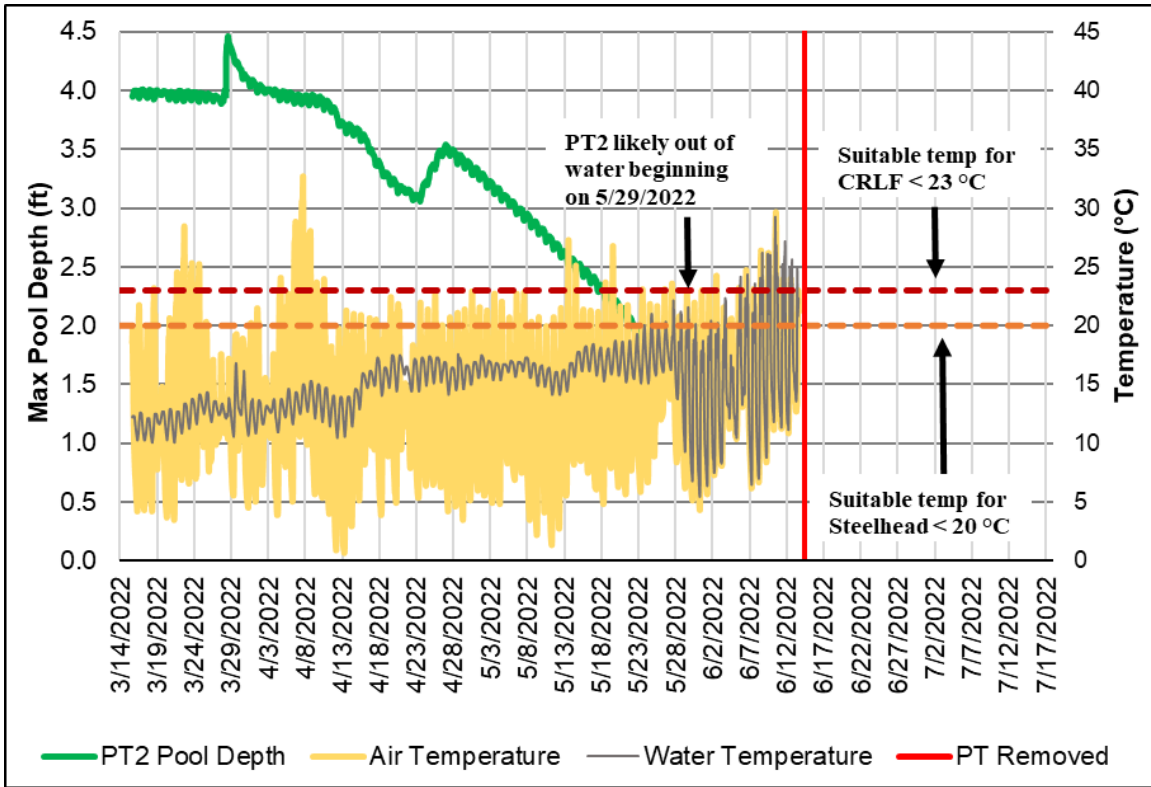
Figure 16. Pool depth and water temperature monitored at PT2.

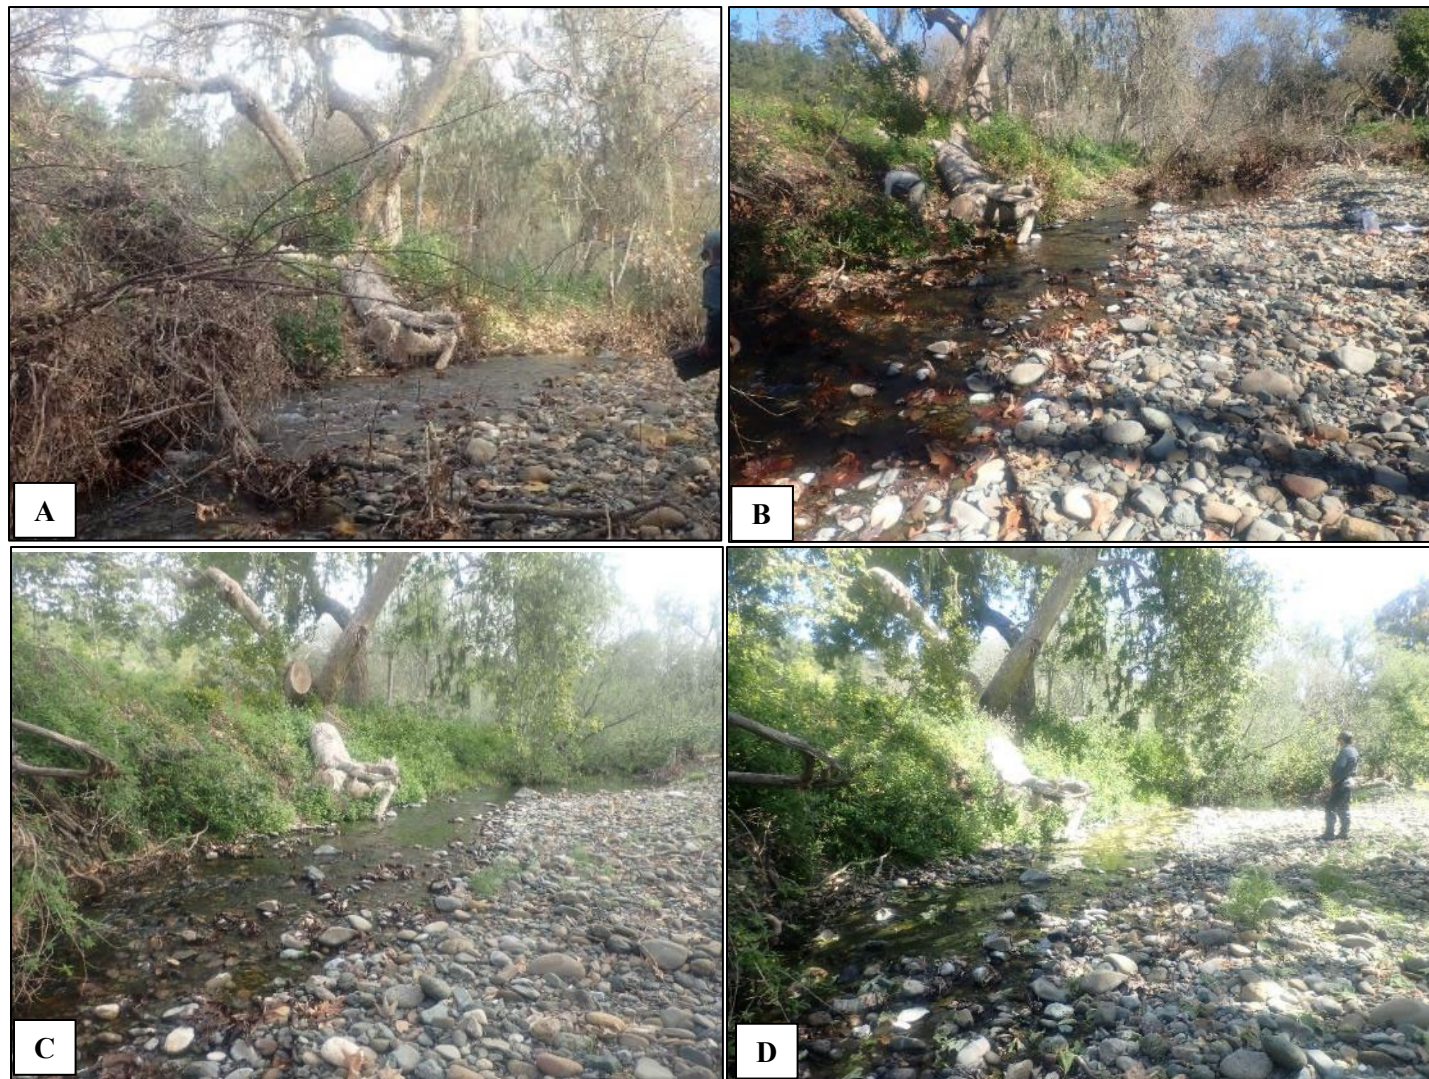
**Figure 18.** Riffle habitat at PPT1\* showing suitable BMI habitat and juvenile steelhead passage at 4.10 cfs (A) and 1.56 cfs (B), BMI habitat but no juvenile steelhead passage at 0.86 cfs (C), and no BMI habitat or juvenile steelhead passage at 0.11 cfs (D).

Observations from the riffle assessments were evaluated to understand what flows supported productive BMI habitat and passage conditions for juvenile steelhead within the Study Reach. Suitable conditions to support BMI production in riffles were observed at all riffles assessed when flows ranged from 4.10 cfs to 0.86 cfs. At flows of 0.35 cfs, suitable conditions to support BMI production in riffles were observed at most riffles assessed while a few riffles no longer supported BMI production. When flows were below 0.35 cfs, no suitable habitat for BMI production was observed at any of the riffles assessed (Table 3). Photos showing riffle conditions over a range of flows are included in Figures 18–23.

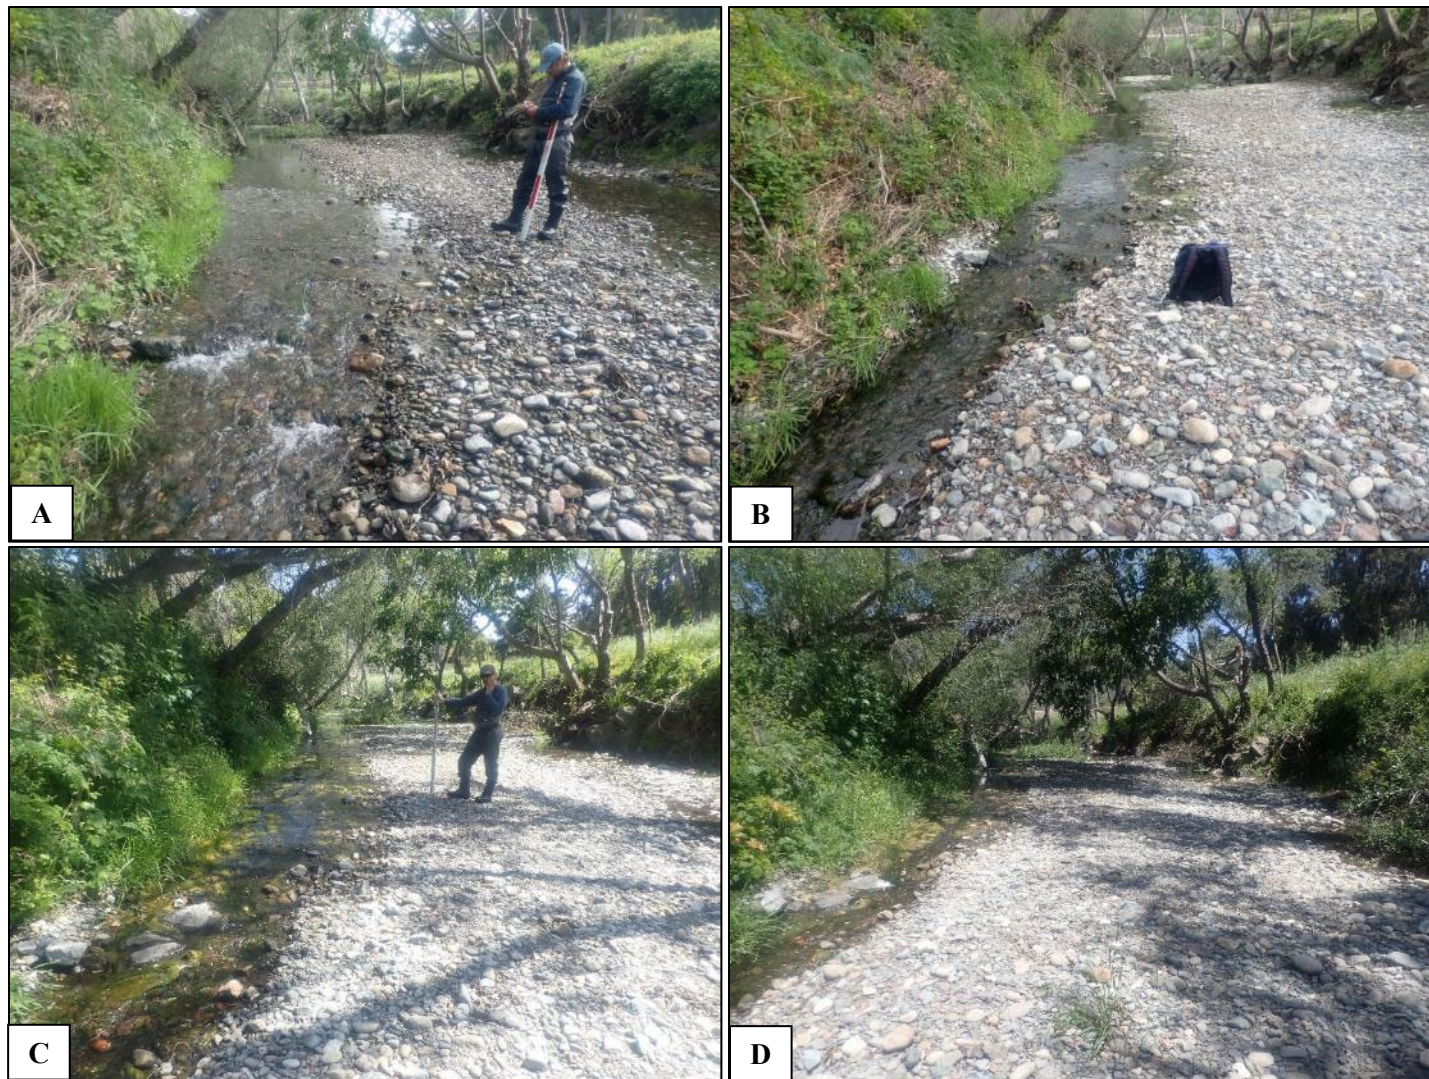
**Figure 19.** Riffle habitat at PPT1 showing suitable BMI habitat and juvenile steelhead passage at 0.86 cfs (A), BMI habitat but no juvenile steelhead passage at 0.35 cfs (B) and 0.11 cfs (C), and no BMI habitat or juvenile steelhead passage at 0.05 cfs (D).

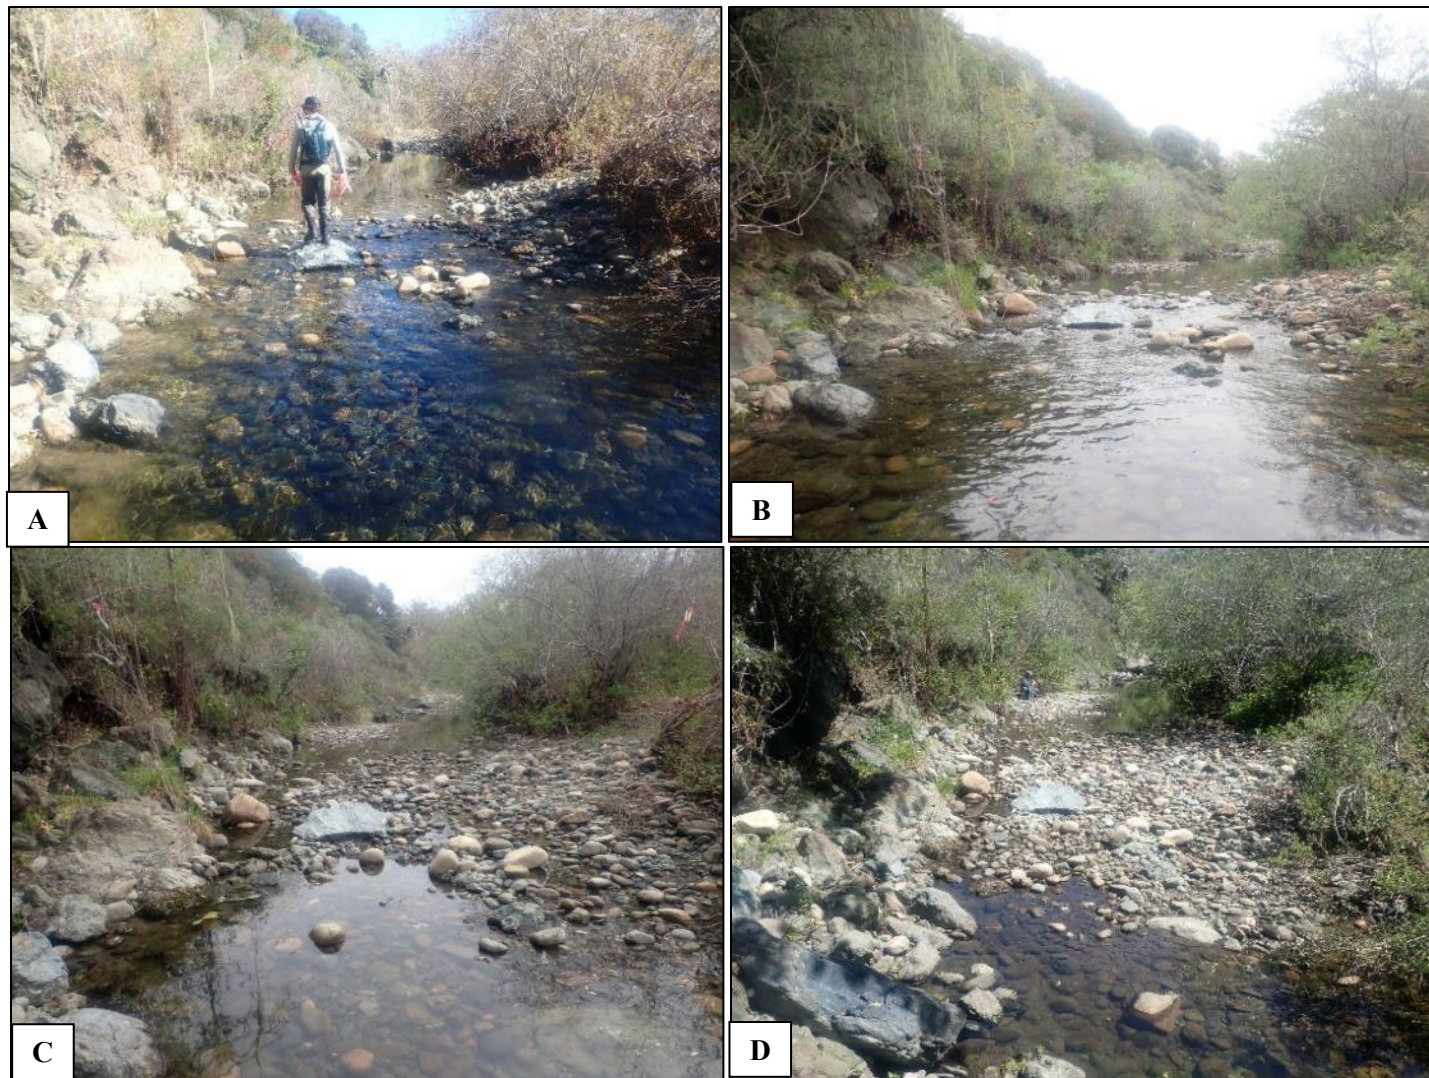
**Figure 20.** Riffle habitat at PPT2 showing suitable BMI habitat and juvenile steelhead passage at 1.56 cfs (A) and 0.86 cfs (B), BMI habitat but no juvenile steelhead passage at 0.35 cfs (C), and no BMI habitat or juvenile steelhead passage at 0.14 cfs (D).

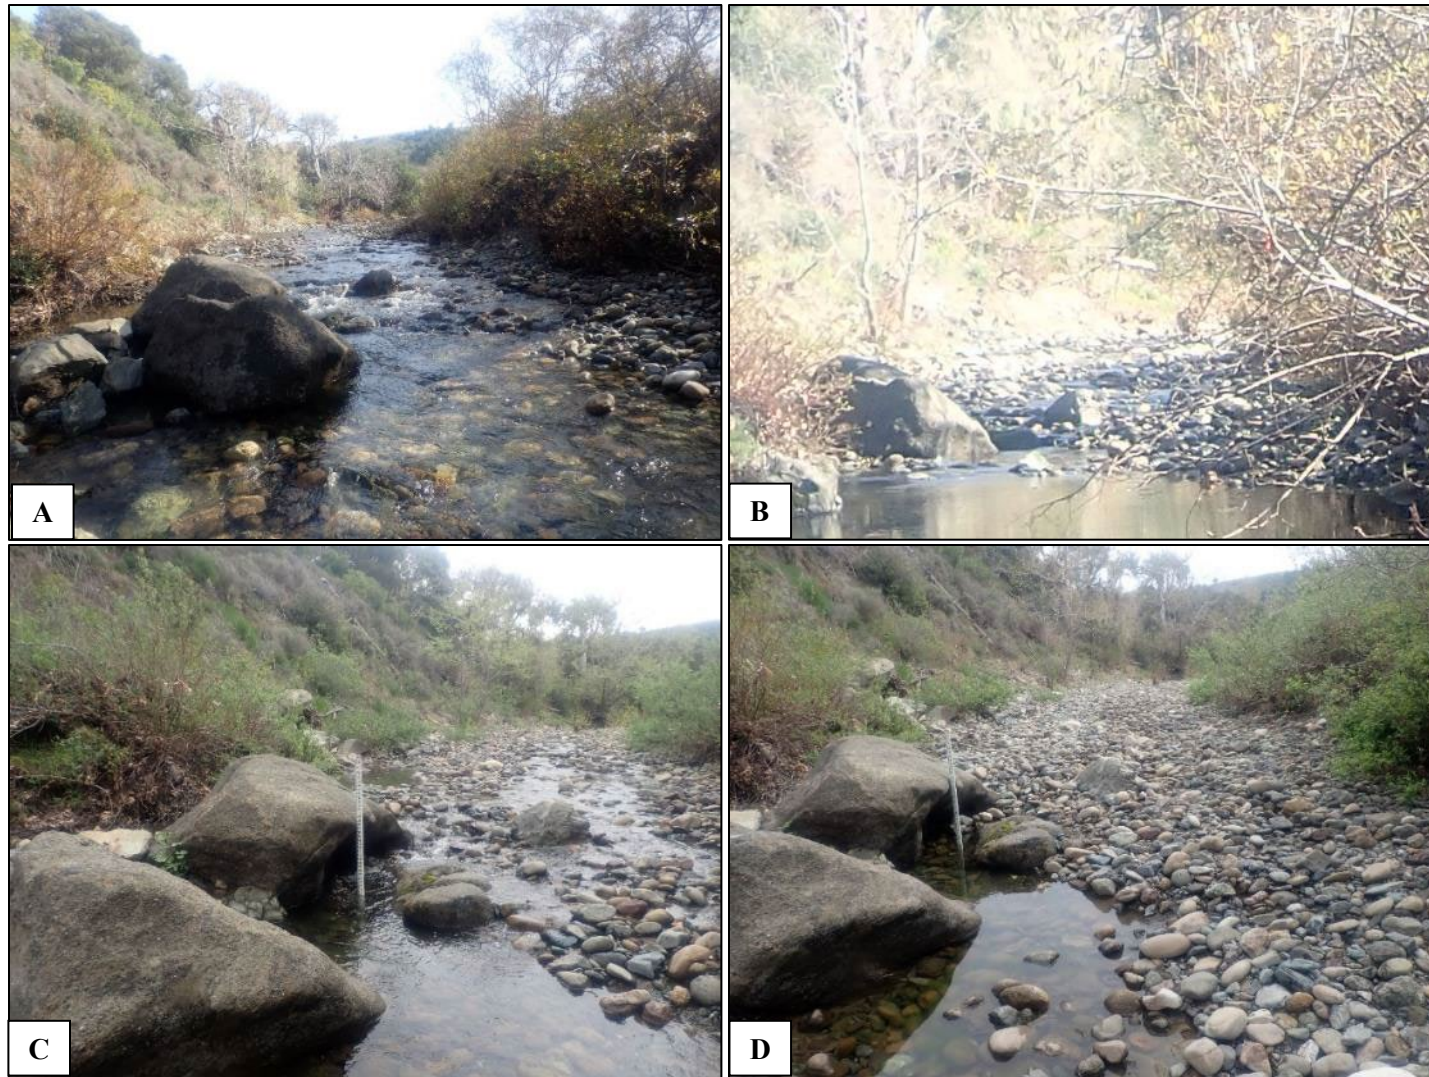
**Figure 21.** Riffle habitat at PPT6 showing suitable BMI habitat and juvenile steelhead passage at 4.10 cfs (A), BMI habitat but no juvenile steelhead passage at 1.56 cfs (B) and 0.86 cfs (C), and no surface flow when flows measured downstream were 0.35 cfs of less (D).

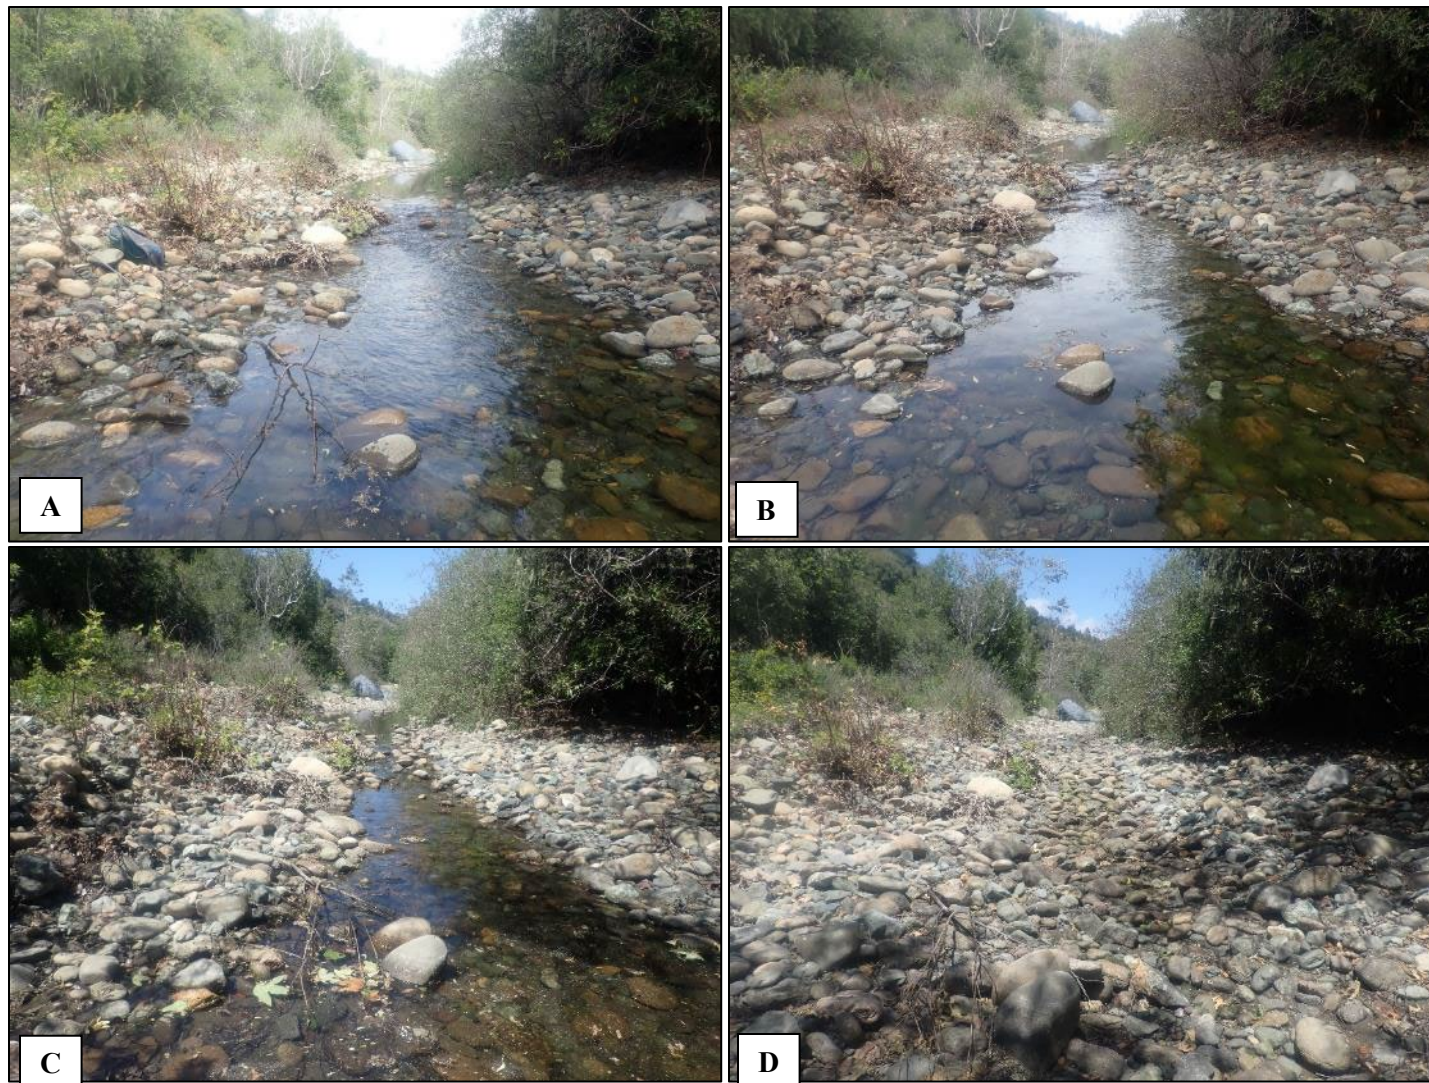
**Figure 23.** Riffle habitat at PPT9 showing suitable BMI habitat but no juvenile steelhead passage at 0.86 cfs (A), 0.35 cfs (B), and 0.14 cfs (C), and no surface flow when flows measured downstream were 0.05 (D).

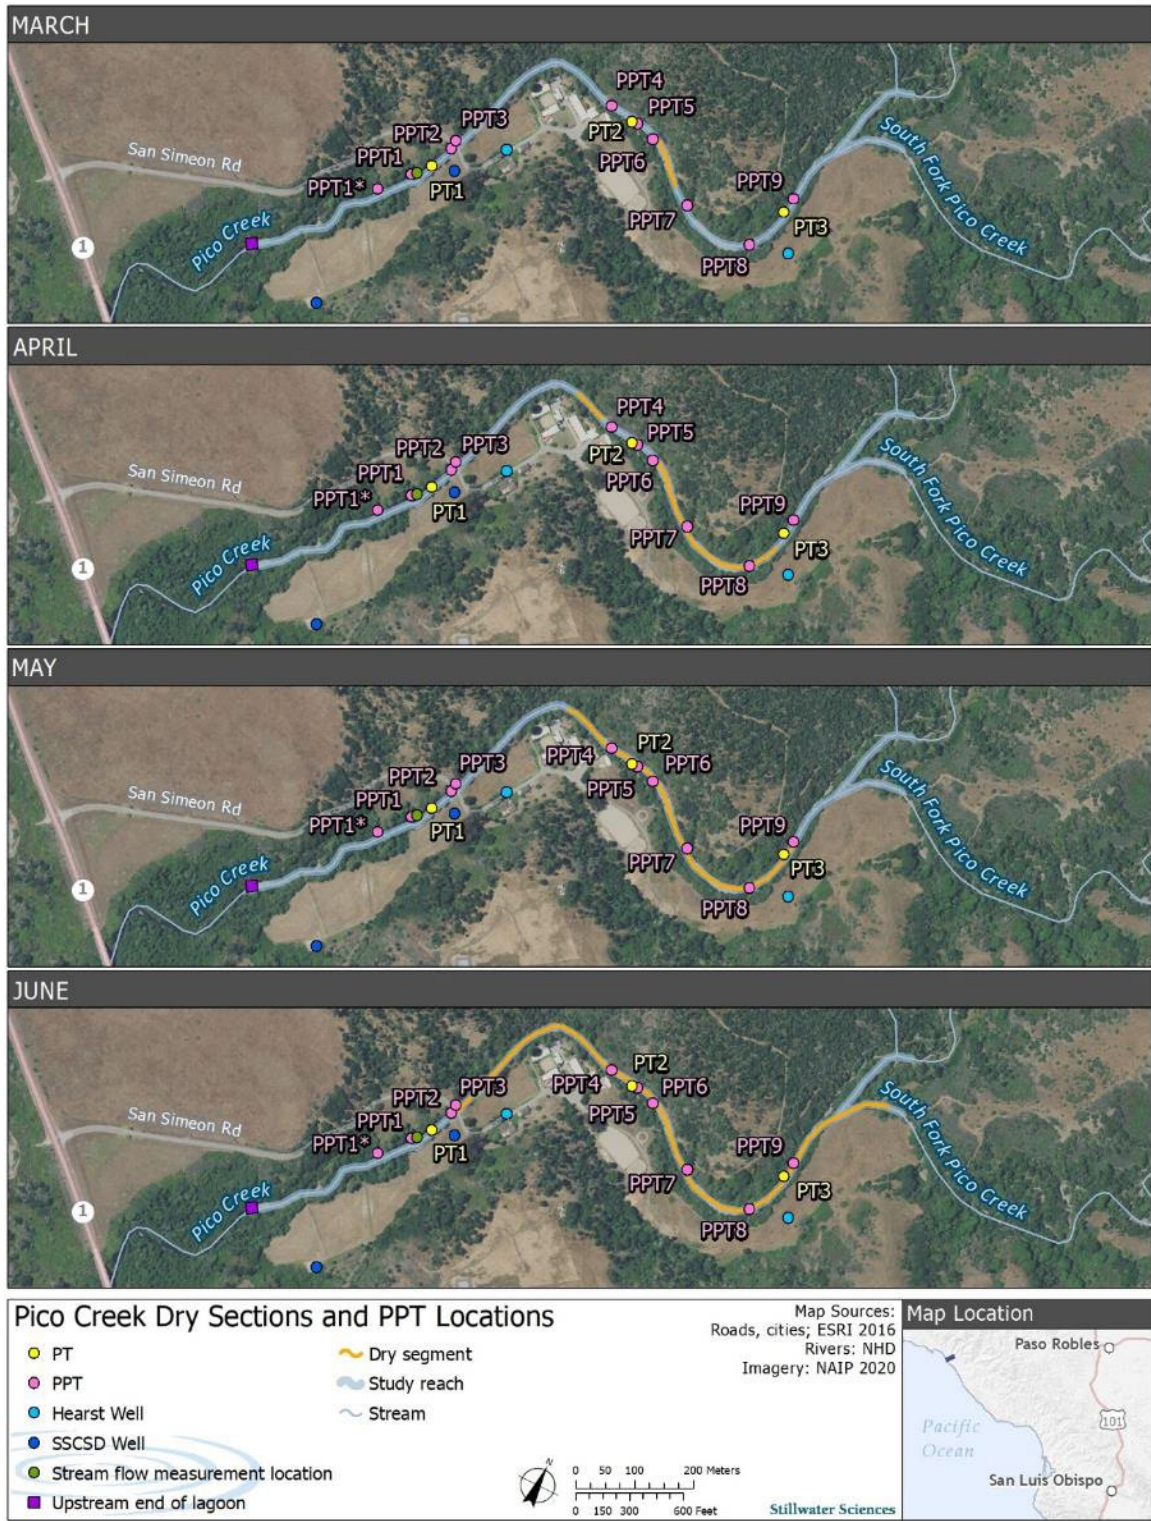
Figure 24. Pico Creek dry segment locations observed during surveys conducted during March through June 2022.

Observations of the stream channel drying out within the Study Reach were observed early in the study. The first observation of disconnected stream flow was observed during March 15, 2022 when a short segment within the middle of the Study Reach (at PPT6) was dry. Following a substantial rain event (1.44 inches) on March 28, 2022, surface flows were observed throughout the entire Study Reach. By April 15, 2022 dry stream channel were observed in two sections within the upper half of the Study Reach and both sections were dry again on April 28, 2022, even after a 0.40 inch rain event occurred on April 21, 2022. On May 9, 2022 the upper half of the Study Reach had no surface flow and water was limited to a few isolated pools. On June 13, 2022, the upper half of the Study Reach was completely dry with no surface flow and no water in isolated pools upstream of the Pico Creek Bridge to the confluence of North Fork and South Fork Pico Creek (Figure 24 and Figure 25). No surface flow was observed throughout the Study Reach on July 12, 2022 but a few small isolated pools were observed between Pico Creek Road and the lagoon.

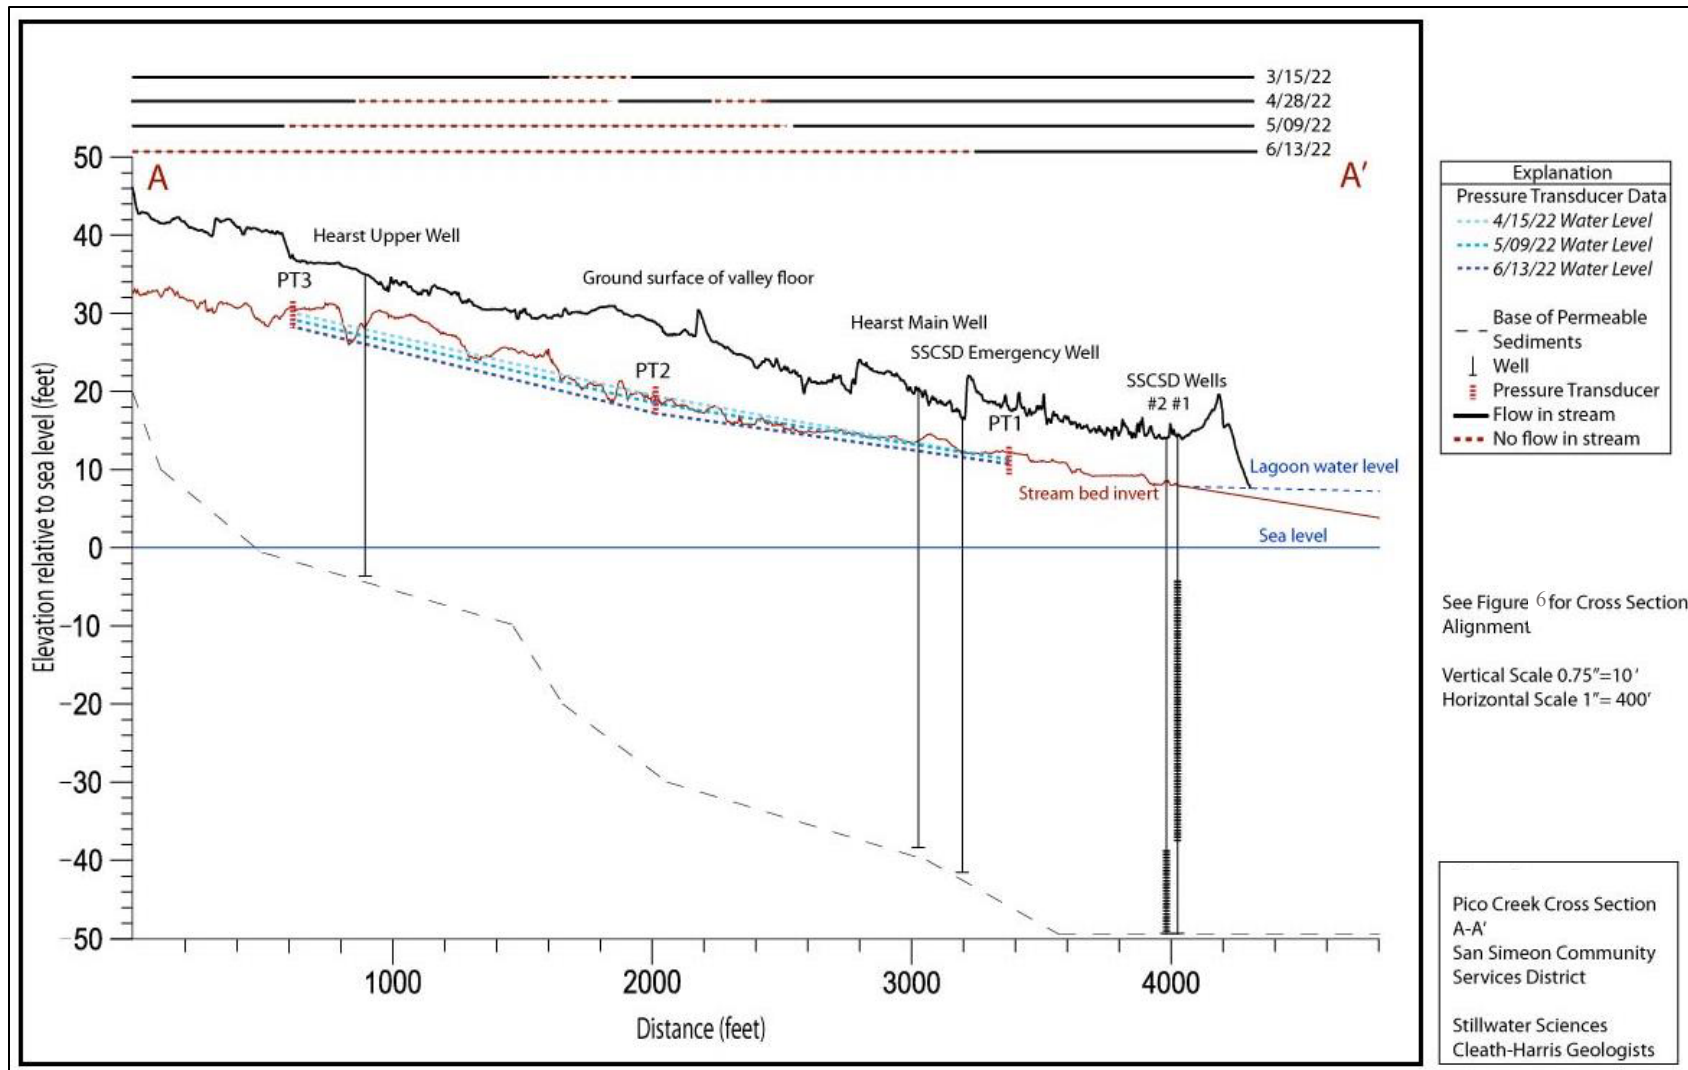
Figure 25. Pico Creek longitudinal elevation profile showing extent of intermittent stream flows in relation to groundwater wells along the Study Reach.
