DRAFT REPORT ◦ NOVEMBER 2022

# Pico Creek Instream Flow Study

P R E P A R E D F O R

P R E P A R E D B Y

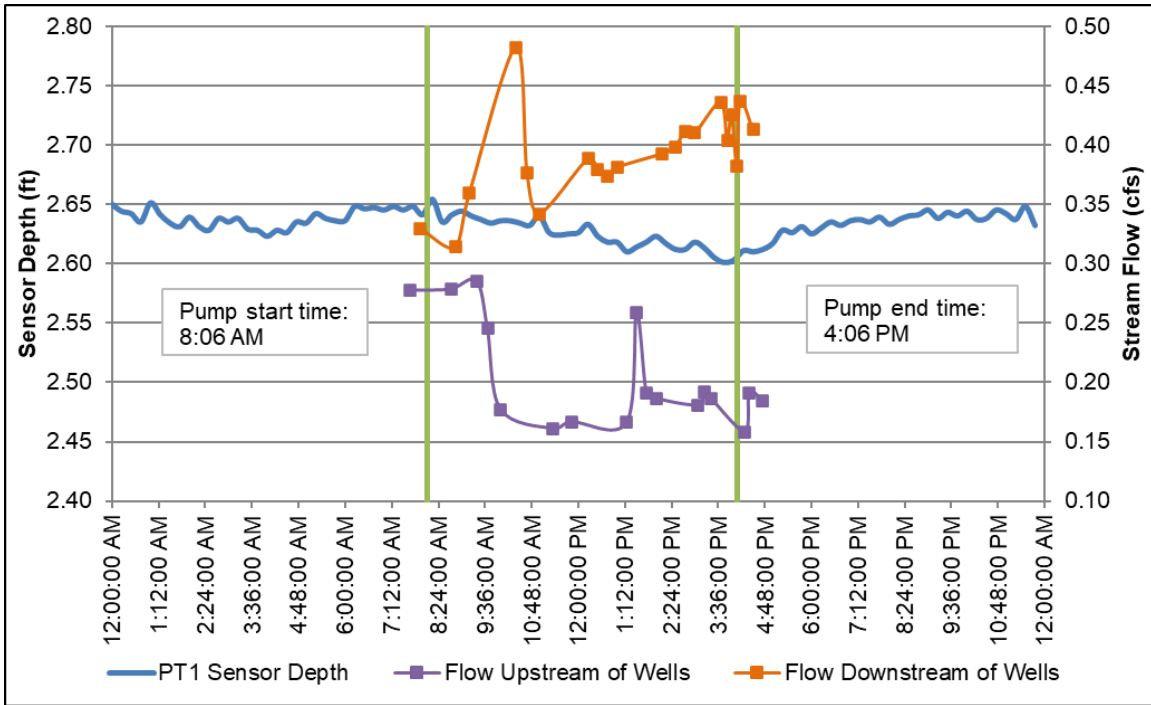
**Figure 26.** Pico Creek stream flow and PT1 sensor depths during April 16, 2022 pump test at District Well #1. Pumping volume on April 16, 2022 was 90,284 gallons, which is equivalent to a rate of 0.42 cfs.

Stream flow during the pump tests at the upstream monitoring point was about half the rate at the downstream monitoring point. Stream flow measurements fluctuated during the tests up to roughly 0.20 cfs during testing at Well #1 and by roughly 0.05 cfs during testing at Well #2. However, the overall trend when the shallow well (Well #1) was pumped shows stream flows decrease by approximately 0.1 cfs at the upstream monitoring point while stream flow at the downstream monitoring point increased by approximately 0.1 cfs (Figure 26). The increase in flow observed downstream of the wells may be due to bank storage-drainage from the shallow aquifer into the stream channel. Stream flow at the upstream monitoring point of the deep well (Well #2) shows a decrease in stream flow of approximately 0.04 cfs, and no detectable trend in stream flow was observed at the downstream monitoring point (Figure 27). The sensor depth at PT1 for both tests declined by approximately 0.05 ft during pumping and then recovered after pumping ceased (Figure 26 and Figure 27). However, the fluctuation in sensor depth observed at PT1 during the pump tests were similar to the daily fluctuations observed during days when District well production was more than half the amount during the pump tests (Figure 28, see daily fluctuations for PT1 on 4/07/2022 and 4/25/2022 when daily well production was around 30,000 gallons).

Based on the daily fluctuations in sensor depths at all three PT sensors monitoring points, the drop in stage level observed at PT1 during the pump tests is likely in part due to evapotranspiration of phreatophyte/riparian vegetation that increases during the daylight hours and decreases as daily light fades. Steep declines in sensor depths observed at PT2 and PT3 began to occur in mid-April, which coincides with the timing when disconnected surface flow was increasing. A sharp increase in sensor depth occurred at PT2 on April 24, 2022 and at PT3 on April 23, 2022 (Figure 28), which are shortly after a 0.4 inch rain event occurred on April 21, 2022 that likely reconnected surface flow and refilled pool habitat (Figure 10). Overall, it appears that groundwater is connected to surface flows in the Study Reach, such that District pumping operations result in a small but detectable reduction in surface flow.

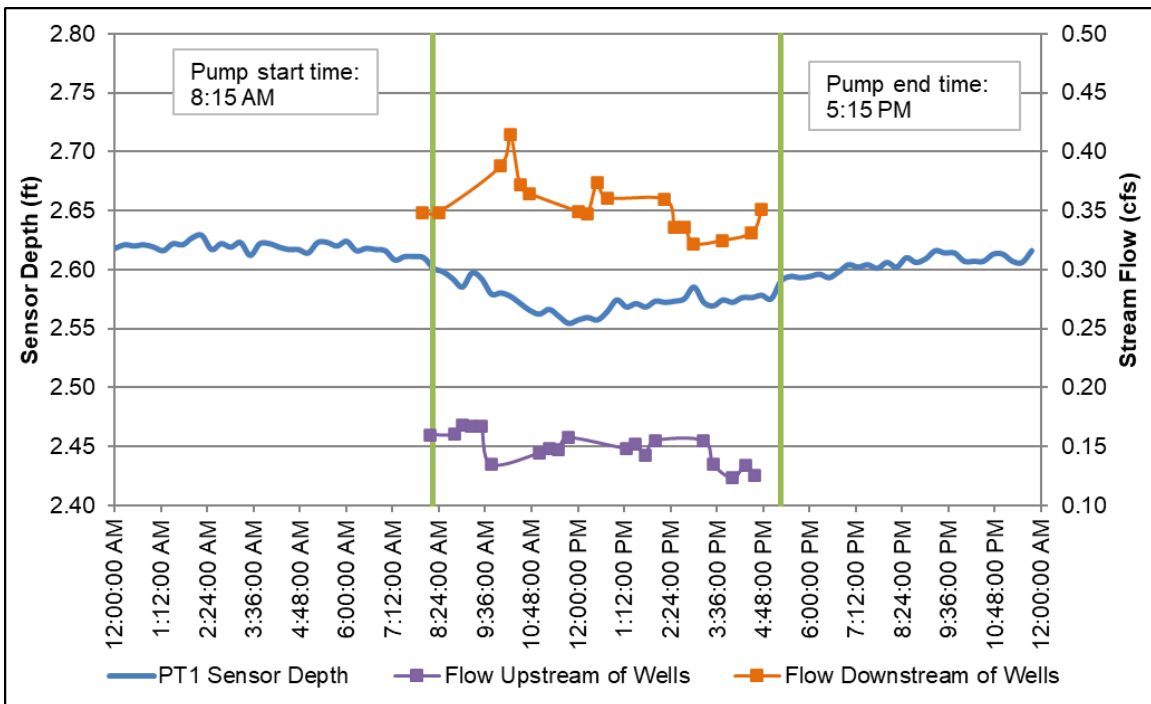
**Figure 27.** Pico Creek stream flow and PT1 sensor depths during April 23, 2022 pump test at District Well #2. Pumping volume on April 23, 2022 was 108,834 gallons, which is equivalent to a rate of 0.45 cfs.

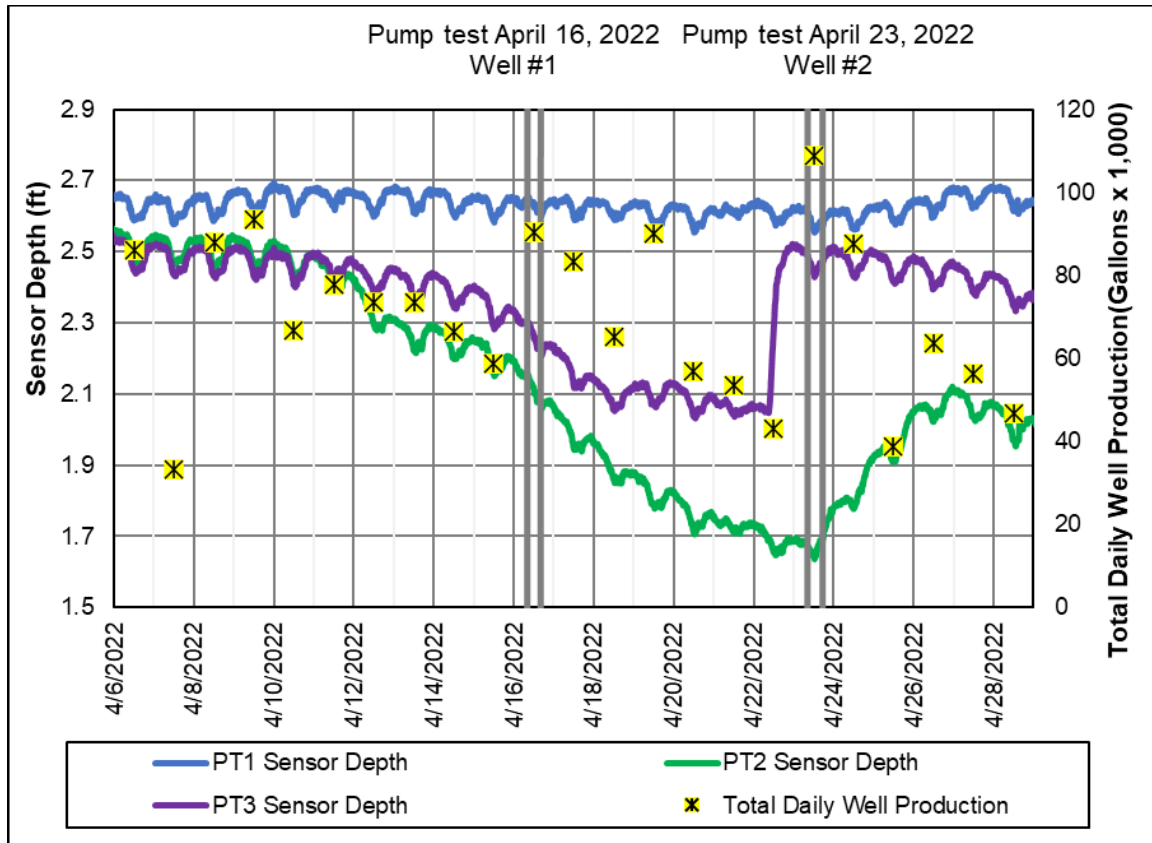
Figure 28. Pico Creek pressure transducer depths and daily well production during April 2022.

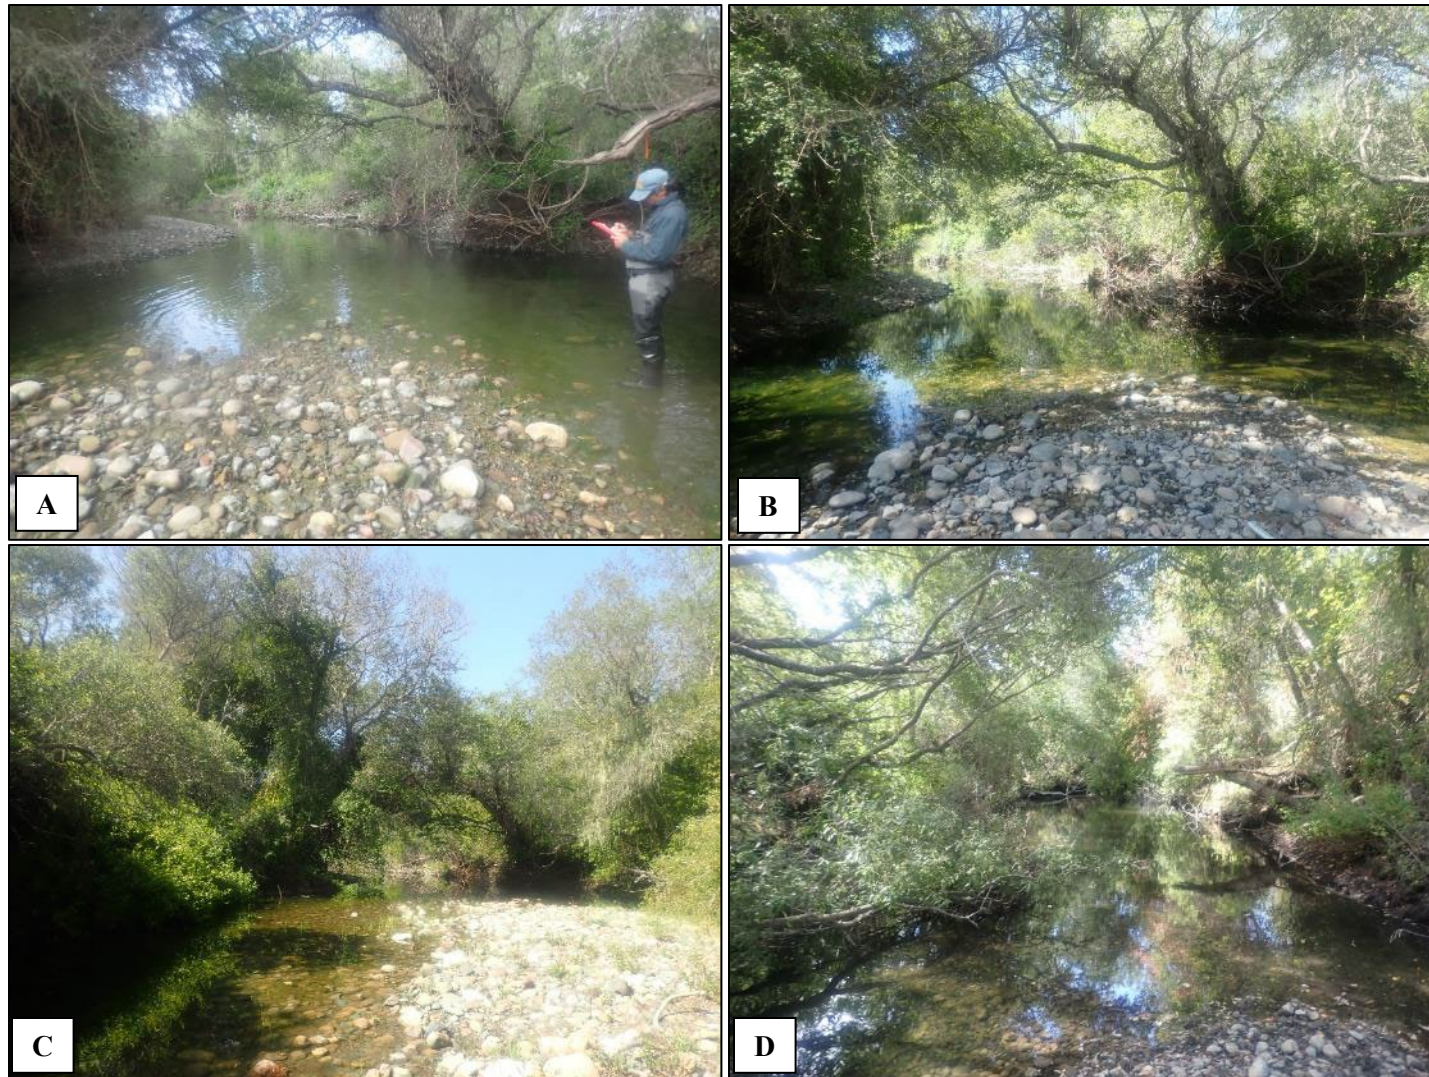
Figure 29. Upstream end of Pico Lagoon on March 30 (A), April 15 (B), April 28 (C), and July 12, 2022 (D).

Water levels recorded in the lagoon showed minor fluctuations (<0.05 ft) on a regular basis each day. These daily fluctuations appear to be correlated with ocean tide heights, as increased sensor depths were generally recorded at high tides while reduced depths were generally recorded at low tides (Figure 29 and Figure 30). Lagoon depths showed a temporal pattern with increased depths in the morning and decreased depths in the afternoon, which suggests evapotranspiration influences lagoon water levels as well.

The magnitude and timing of daily fluctuations in the lagoon water levels appeared similar during the pump tests compared to days when pumping was reduced. The fluctuation observed in lagoon water levels appears to be the result of tidal activity and evapotranspiration. No impact to the lagoon due to pumping was evident during the test.
